## Challenge

Rescue a 20-year-old split case pump running far off BEP and achieve a cost avoidance of \$225K for a new pump.

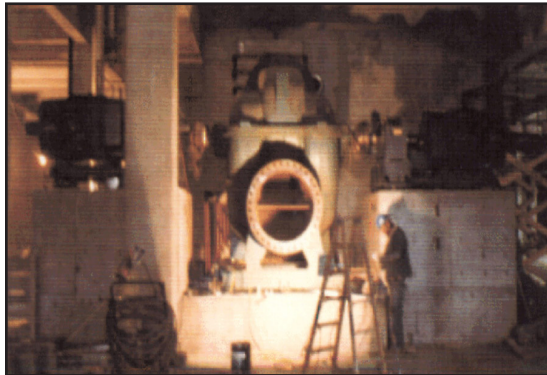
Sulfuric acid added to pulp increased internal corrosion in a pump that was already worn.

Disassembled pump prior to installation

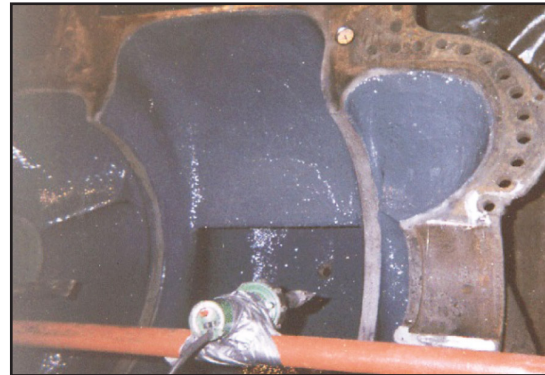
Split case fan pump, coated with ARC 855, ARC 858 and ARC 890

1. Rebuild cut-water using wire mesh and **ARC 890**
2. Use **ARC 858** to coat and fill pits and gouges
3. Apply 2 coats of **ARC 855** in alternative colors over repaired and uncoated metal

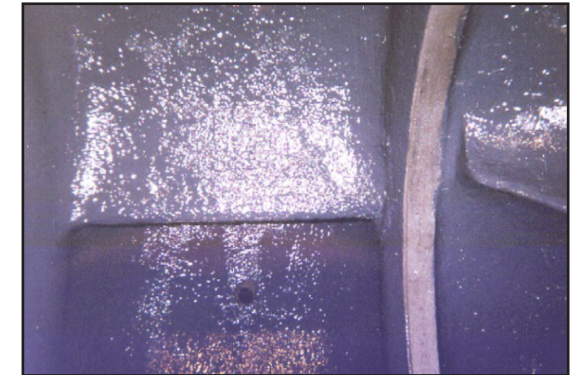
Damaged cutwater rebuilt with ARC 890 and topcoated with ARC 855
