Challenge

Drainage pump volute and impellor eroded and corroded by pumping sand, water, and acidic run off.

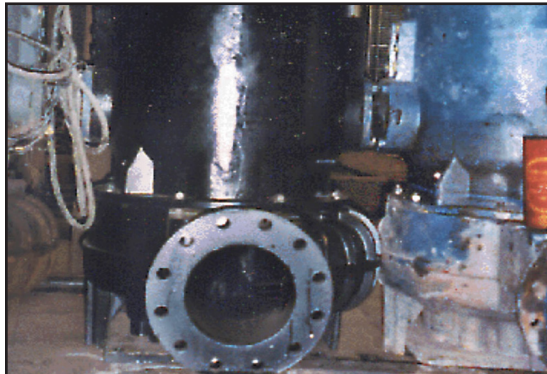
Submersible pumps subjected to adverse conditions

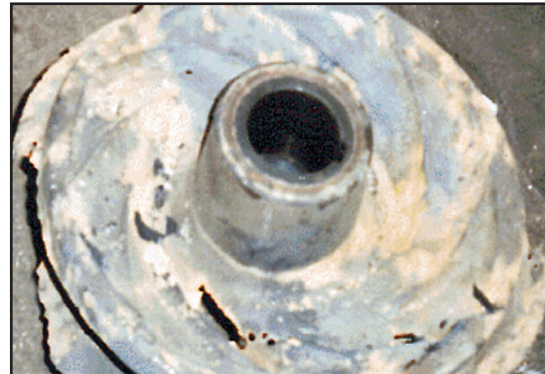
Corroded impeller from submersible pump

- Abrasive blast to Sa 2.5 with 3 mil (75 µm) angular profile

1. Apply **ARC 858** to replace metal loss and repair large damage
2. Topcoat with **ARC 855**, the ceramic reinforcement to provide erosion/abrasion resistance and enhanced flow efficiency

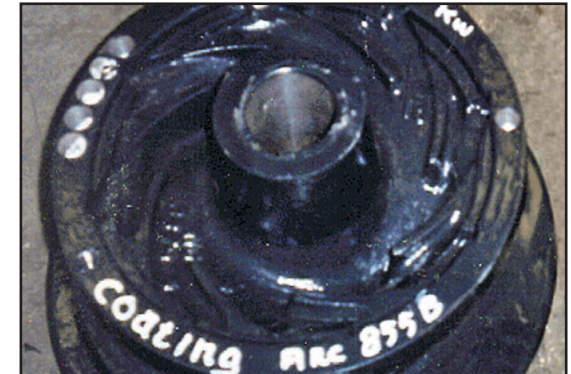
Coated impeller awaiting installation in submersible pump
