## Challenge

Primary fan pump damaged by erosion/corrosion had high replacement cost for cast steel spare (\$75K), and stainless steel (\$105K) with long lead times (>4 weeks).

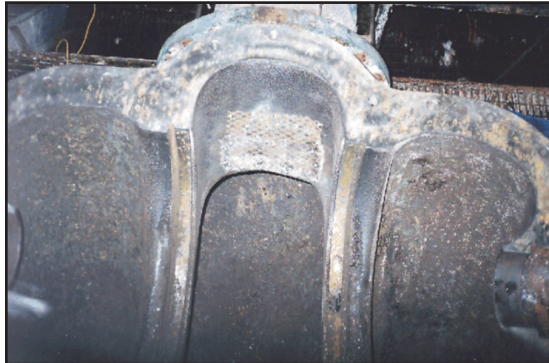
Increased use of clay as a blocking agent in the paper stock was abrading away internals of cast iron pump.

Damaged surfaces of pump

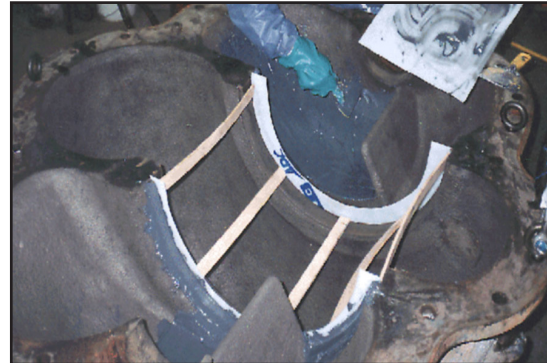
Re-building with ARC 858

- Decontaminate surface
- Reestablish damaged cutwater by using expanded metal mesh
- Grit blast to Sa 2.5 with 3 mil (75 µm) angular profile

1. Imbed **ARC 858** in metal mesh to rebuild cutwater
2. Apply **ARC 858** to fare pitted areas
3. Apply 2 coats **ARC 855** to a total DFT of 30-40 mils (0,75 mm - 1 mm)

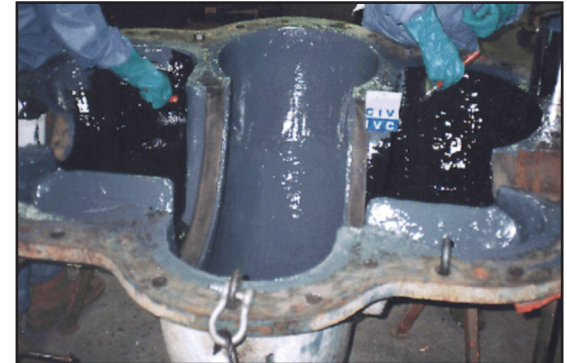
Final topcoat of ARC 855

- At 1 year inspection no damage to coating
- Client saved over \$70K compared to purchasing new high alloy pump
- Repair completed in 36 hours vs 4 week lead time for spare parts
- Application has been repeated several times at this mill on other pumps including mill effluent pumps and various stock transfer pumps
