## Challenge

Damage from erosion and cavitation required three week's of repairs to address welding and grinding.

Reduce the effects of cavitation damage on turbine blades and reduce downtime associated with repairs.

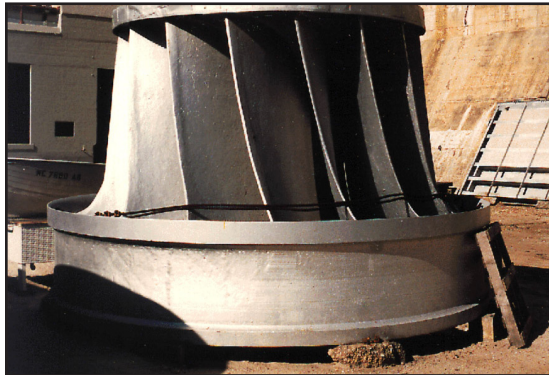
Vanes of turbine were eroded and impacted due to high suspended solids content in water and cavitation from low flow.

A Francis turbine prior to coating

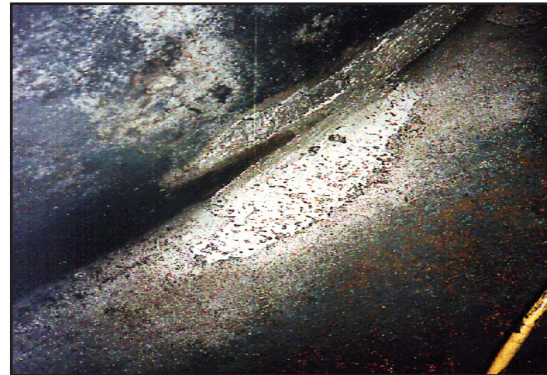
Cavitation damage is evident after proper surface cleaning

- Abrasive blast surface to Sa 2.5 with 3 mil (75  $\mu$ m) angular profile

1. Apply **ARC 858** to the cavitation affected areas, rebuilding any metal loss
2. A subsequent top coat system using two alternating color coats of **ARC 855** applied for a smooth surface finish

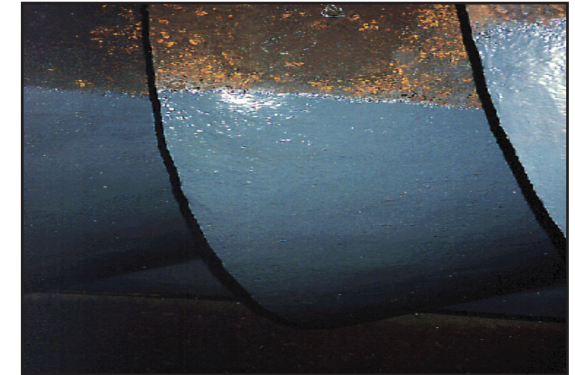
Top coat of ARC 855 on the cavitation affected blades

- ARC coating solutions reduced maintenance from 21 days per year to 3 days per year
- While cavitation still occurs, only the coating is being damaged which can be quickly and easily repaired
