Glass flake coating failure caused general erosion/corrosion damage to fan and excess dust attachment caused imbalance and premature bearing failure.

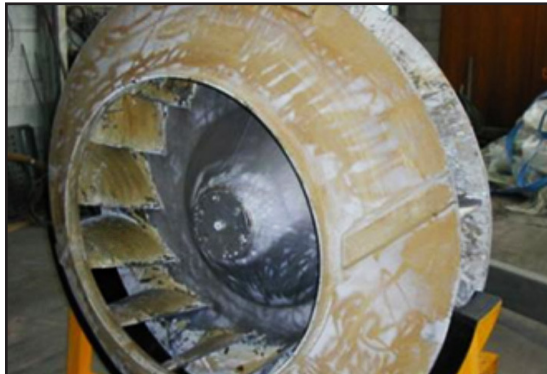
Corrosive gases caused corrosion of exposed metal surfaces. Dust attachment caused imbalance and vibration.

Six months of erosion and build up

- Blast off old coating
- Decontaminate surface
- Grit blast to Sa 2.5 with 3 mil (75 µm) angular profile

1. Apply **ARC 858** to worn and pitted areas
2. Apply 2 coats of **ARC SD4i** to final DFT: 60 mils (1.5 mm)

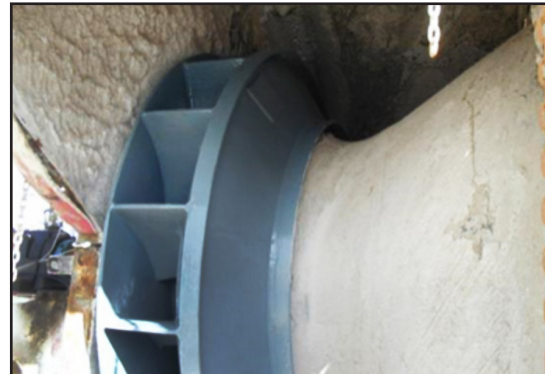
Installed fan coated with ARC

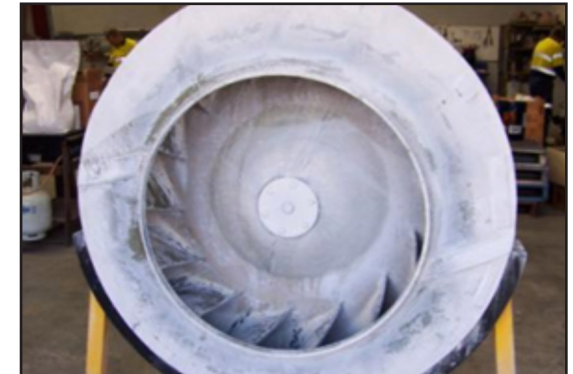
- Virtually no build up at 6 months
- Vibration no longer an issue, bearing life extended
- No erosion or corrosion at 6 months
- Back in service in 1 hour after inspection, inspections now yearly vs bi-annually

After 1 year inspection: put back in service
