Goal

- Provide an emergency temporary repair to bridge the 6-week lead time to get a new steel liner by repairing the existing one with an ARC coating in order to meet production goals

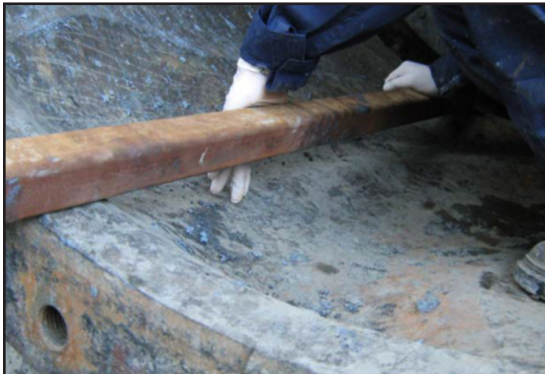
Worn rubber boot seal allowed abrasive mill media and ore into liner housing, wearing away ID of housing.

Severity of wear on ID of trunion housing

- Abrasive blast clean to Sa 2.5 with 3 mil (75 µm) angular profile

- Screenshot apply **ARC BX1*** to ID of liner at DFT of 3" (76 mm) to form an abrasion resistant surface

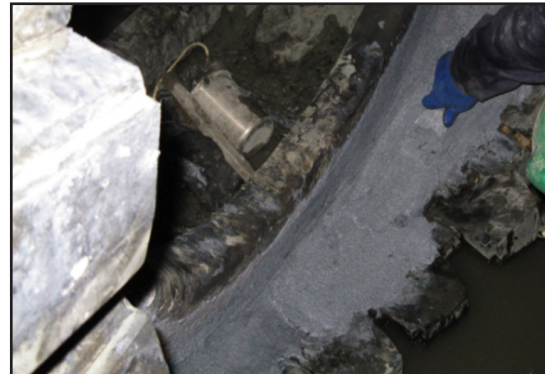
Applying ARC BX1*

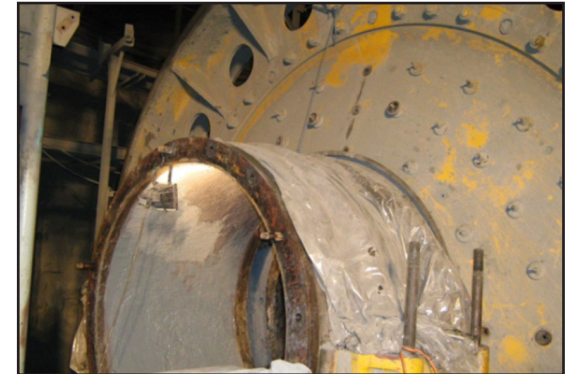
Installed housing

- Mill back in service within 72 hours of application
- Mill ran for an additional 14 weeks (20 weeks in total) before new liner was installed
