Challenge

Weld overlay caused heat stress cracking and leaks resulting in 6 month maintenance cycle.

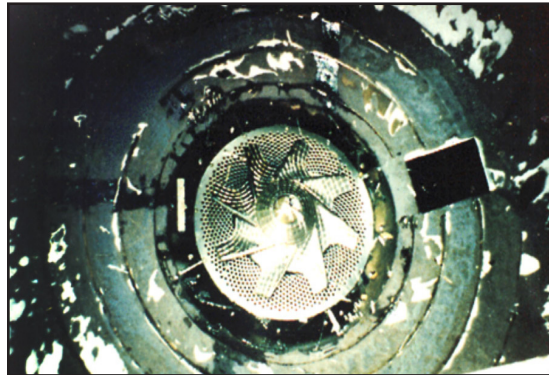
Recycled paper bales impact floor of hydropulper and entrained solids abrade internals.

Severe wear of hydropulper

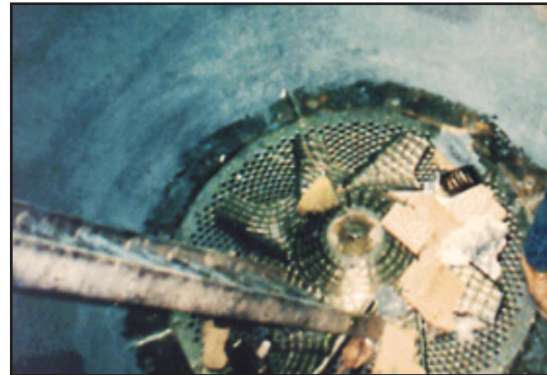
Application of ARC BX1

- Grit blast to Sa 2.5 with 3 mil (75 µm) angular profile
- Wire mesh welded over existing holes

1. Apply **ARC BX1*** over wire mesh
2. Apply **ARC BX1*** minimum ¼ inch (6 mm)

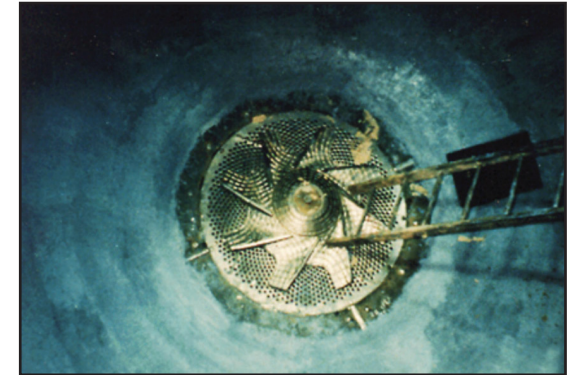
- >36 month service life
- Client indicated savings in downtime, increased efficiencies and increased reliability

Protected hydropulper
