Challenge

Ship loading capability from failed rubber lined granulated slag chute was reduced by abrasive wear. Materials and labor cost to replace chute exceeded maintenance budget.

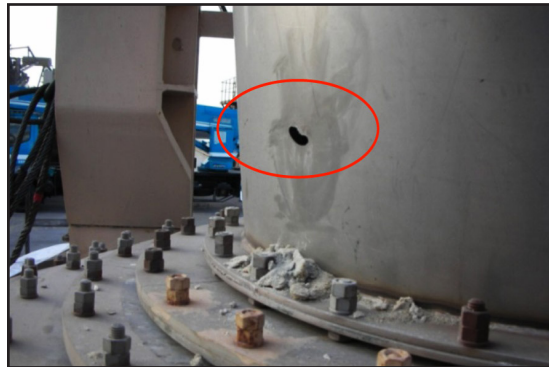
Severe sliding abrasion from granulated slag discharged through the chute created holes in rubber liner and steel body of loading chute.

Granulated slag creates holes in the loading chute

Abrasive blast to Sa 2.5 with 4 mil (100 µm) angular profile.

1. Apply .240" (6 mm) **ARC MX1** to the upper 3 sections of the chute with highest wear
2. Topcoat and smooth with **ARC S2**

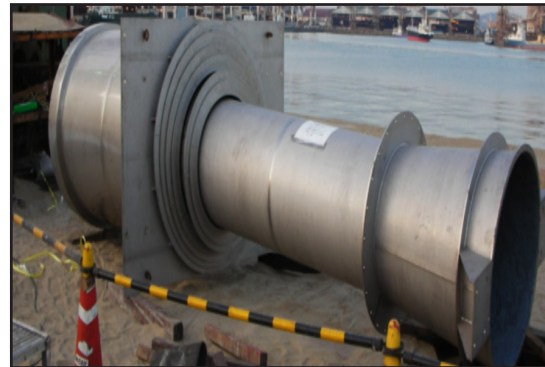
The telescoping granulated slag chute at discharge pier in steel mill

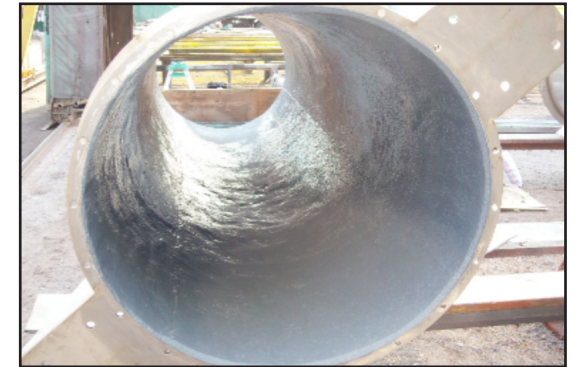
Finished section of the slag chute
