Challenge

Issue

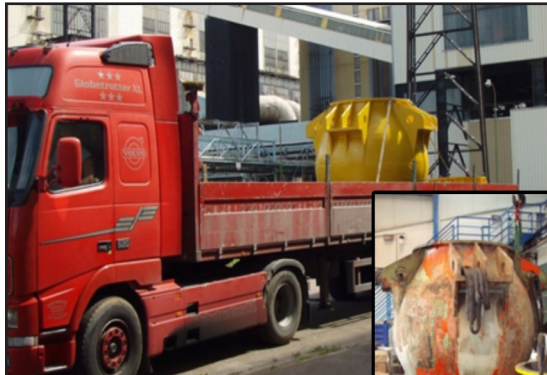
Erosion from river water had worn suction vanes and volute of pump resulting in cavitation. In addition, extensive pitting corrosion had occurred.

Pump and end bell housing transported of site to shop

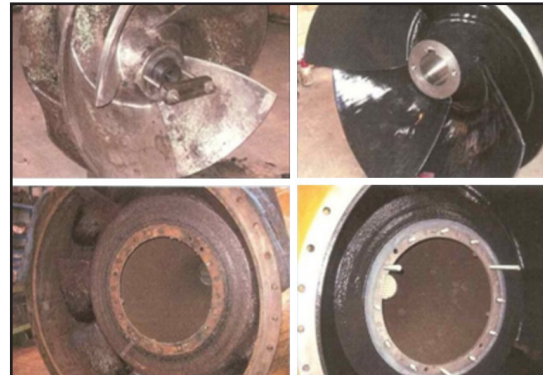
Before and after of elements

1. Suction vanes and volute casing were rebuilt and fare smooth with **ARC 858**
2. Apply 3 alternating color coats of **ARC 855** @ total DFT of 45-60 mils (1-1.5 mm)
3. Following application, balanced impellor
4. Replace mechanical packing with 442J split seal

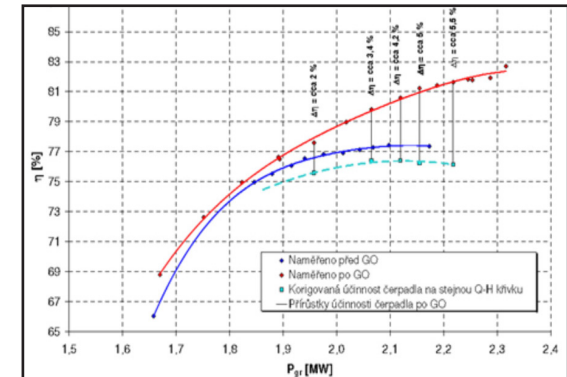
- Performance improved by 6.25% from 6.3 M3/sec to 6.7 M3/sec. Overall pump efficiency was increased by 4.2%, resulting in an energy savings of 425 MWh/year
- In addition, pump continues to perform at same level after 3+ years in service with no discernible loss of performance or efficiency

Green(before) / Blue (OEM curve) / Red (after)
