Challenge

Increase turbine maintenance due to severe corrosion at tube to tube sheet ligament. Frequency of plugging was reducing condenser efficiency.

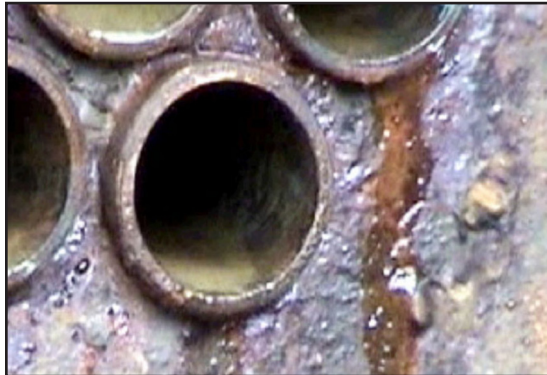
Galvanic corrosion between copper tubes and carbon steel tube sheet.

Original condition of the tube sheet

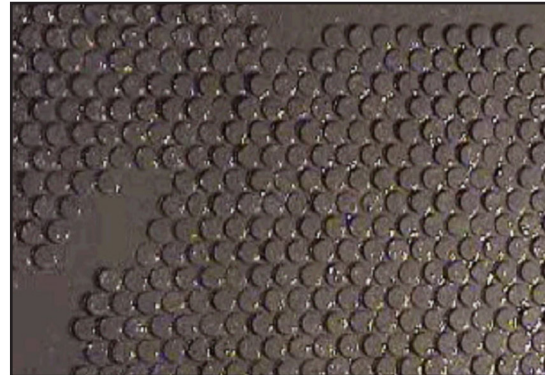
Tube Sheet after S2 application, prior to plug removal

- Plugging ~18,000 tubes to protect from blast cleaning
- Grit blast to Sa 2.5 with 3 mils (75 µm) angular profile

1. Apply 2 coats of **ARC S2** at wft of 8-13 mils (200-325 µm) per coat

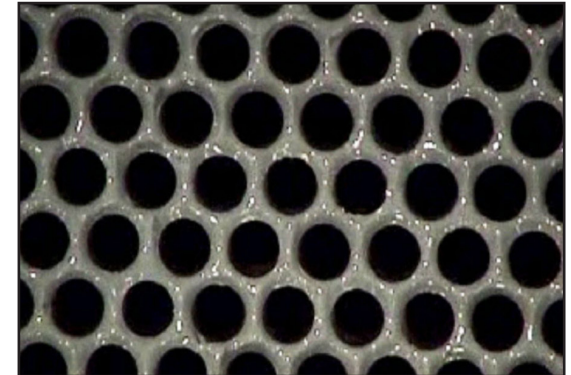
- At 3 year service inspection interval equipment considered in excellent condition
- Client rates condenser at 98% efficiency of new
- Based on results to date and data from similar equipment, client indicates expectation of ARC service life to 12+ years

Completed tube sheet
