Various areas with high metal loss were found when inspecting a salt water pump, which were affecting performance.

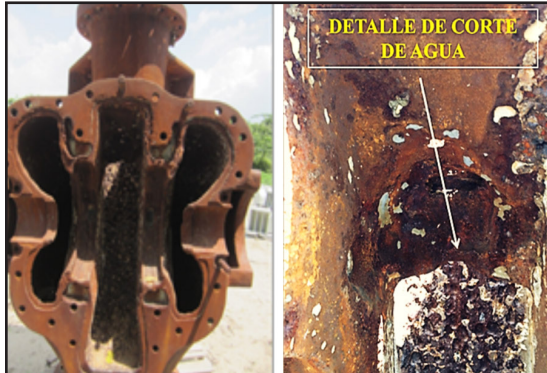
The corrosive conditions added to content of solids in pumped fluid, cause corrosion and erosion.

Pump body as inspected

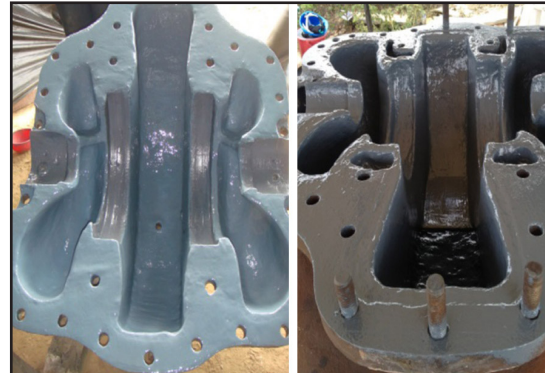
Repair being performed, body and cover

- Clean with 338 SRR and hot water
- Grit blast to Sa 2.5 with 3 mil (75 - 125 µm) profile

1. Weld metal plate in cut water and apply **ARC BX1** @ 250 mils (6 mm)
2. Apply **ARC 10** @ 80 to 160 mils (2-4 mm) on flanges and machine to level
3. Apply **ARC 858** @ 250 to 315 mils (3-8 mm), to mold wear ring seats and smoothen all internal surface
4. Apply **ARC S2** in a 2 coat system @ 20-24 mils (500-600 µm) on all internals

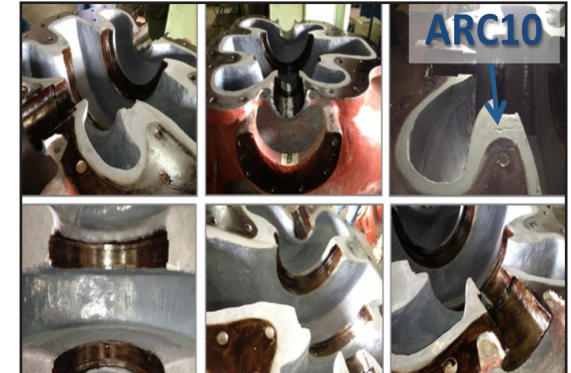
Reconstructed and finished pump
