Challenge

Issue

Severe vibration and cavitation in draft tube leading to loss of bolted steel plates. Shutdowns to repair/replace steel plates are expensive and require 30 days on average to complete.

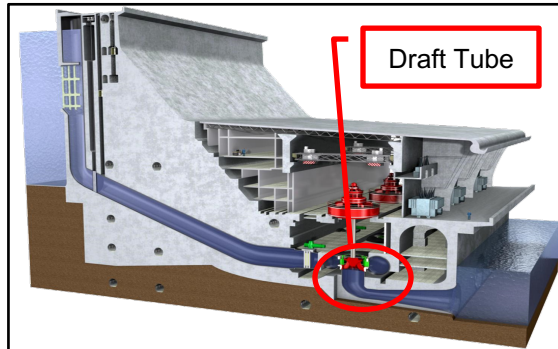
Flow at $>50 \text{ m}^3/\text{sec}$, along with high level of suspended solids during spring runoff also caused to concrete and rock walls.

Before: draft tube.

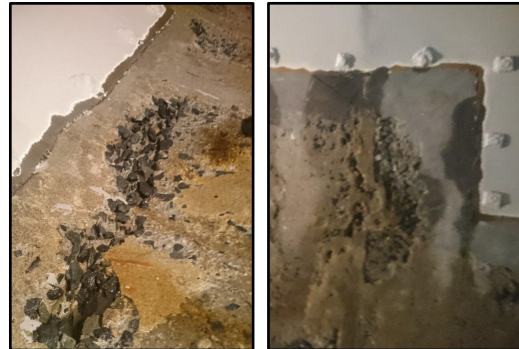
In process: damaged areas with raw steel plate edge shown loose on left and reattached on right

Preparation high pressure water blasting was first used to remove loose concrete. This was followed by re-bolting loose plates and pressure grouting underneath.

ARC 791 was applied directly to prepared concrete and bare rock wall at thicknesses ranging from 6 mm – 15 mm. This approach eliminated further bolting and eliminated air pockets where vibration could occur. Application carried out in <7 days.

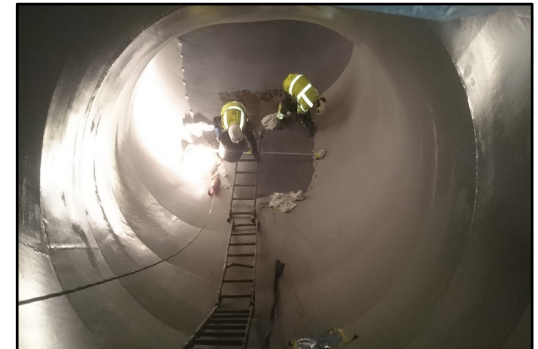
Initial application done in 1994 was inspected after five years and found in excellent shape. This led client to authorize repair on larger unit with same issue.

After: completing application of ARC 791
