Cavitation and erosion damage on the wicket gates was causing premature failure of gate and lowered operational performance. Required replacement or repair of gates.

Repair the edge of the wicket gates and provide protective coatings 14" back from the edge.

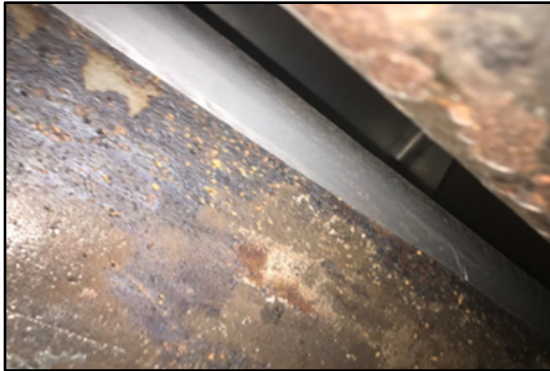
High erosive flow rates with some entrained solids caused severe corrosion/erosion. Some cavitation occurred as damage to gates progressed.

Before: Worn leading edge of wicket gate.

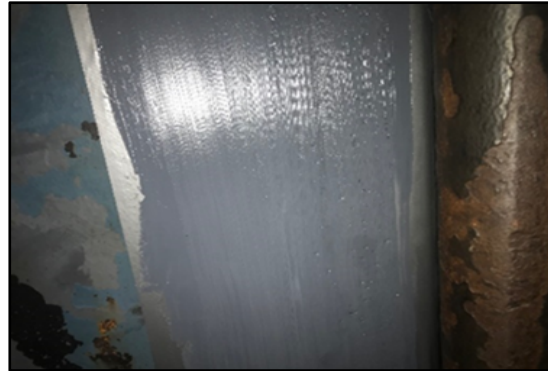
In process: Application of ARC 858 rebuild coat.

Areas requiring repair were grit blasted to Sa 2.5 cleanliness with 3+ mil angular profile.

ARC 858 used to rebuild zones of damage and metal loss. Nominal thickness applied were 125 mils overall. Some areas received a coat of ARC 858 at >250 mils.

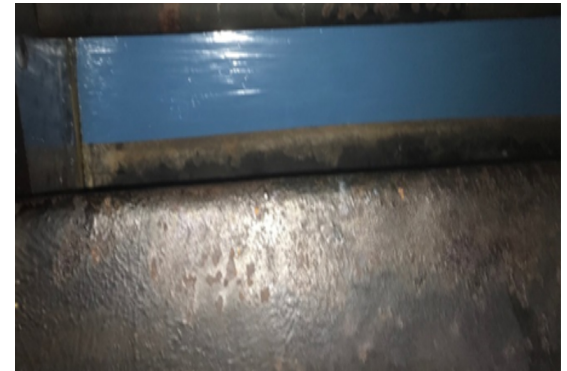
After: Final topcoat of ARC SD4i.

Following the rebuild, all surfaces were top-coated with two coats of ARC SD4i in alternating color coats of 12 – 15 mils/coat.
