Challenge

Issue

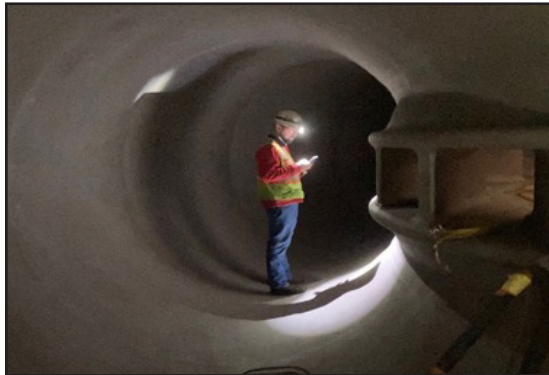
Severe erosion had washed out previous lining after <6 months. Erosive flow damage was evident on exposed metal surfaces.

As water transitions from laminar to radial flow mechanical/erosion damage occurs at leading edges of stay vanes and outer race of scroll case.

Scroll case and stay vanes after grit blasting.

Grit blast to remove previous coating and create 75 µm (3+ mil) angular profile with a near white surface cleanliness.

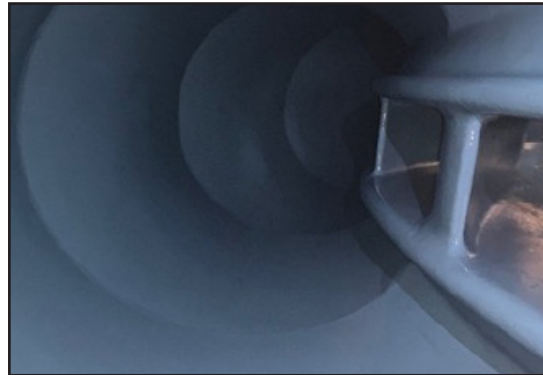
Scroll case and stay vanes coated with **ARC SD4i**.

ARC 858 used as a faring compound to fill in pitted and eroded sections prior to top coating with **ARC SD4i**. The **ARC SD4i** coating was applied to prepared metal and metal repaired with **ARC 858** while **ARC 858** was within overcoat window. A total 1.1 mm – 1.5 mm (45 – 60 mils) total DFT were applied in alternating colors for visual wear indications.

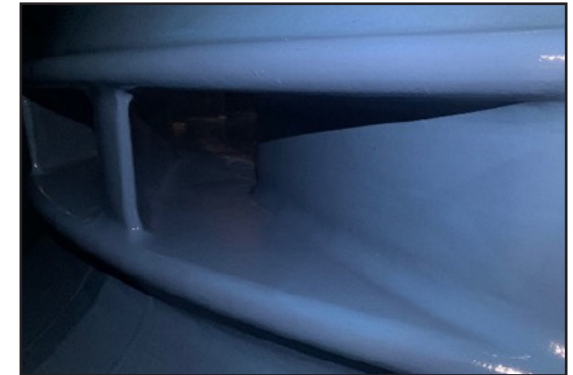
After 12 months in service, inspection revealed <.05% of coated surface area had seen coating damage, primarily tied to galvanic coupling at scroll case (CS) to wicket gate transition (SS).

Final coat of **ARC SD4i** on stay vanes.
