Challenge

Background

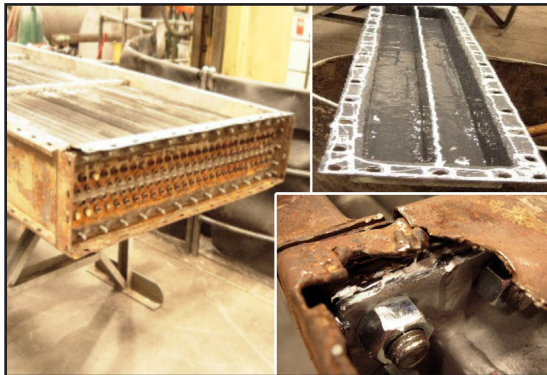
Original coils had to be cleaned and put back in service. Coil tube sheet and water box seal surfaces were eroded and rough.

- The customer required a fast turnaround to repair the cooler. Time constraints would not permit replacement of isophase coils
- The primary cause of the header leakage was rough, corroded, sealing surfaces

Isophase Cooler, Chesterton 860 MPG applied to water box and a close up view of 860 MPG and seal joint.

Chesterton 860™ Moldable Polymer Gasketing (MPG), which has the ability to fill corroded surfaces and create a flat sealing surface.

- ARC 10 industrial coating to rebuild the damaged sealing surfaces
- Installation was fast and easy

Chesterton 860 MPG was applied to the tube sheet channels and the water box. The unique 2-component sealant cured even in areas up to 6 mm thick.

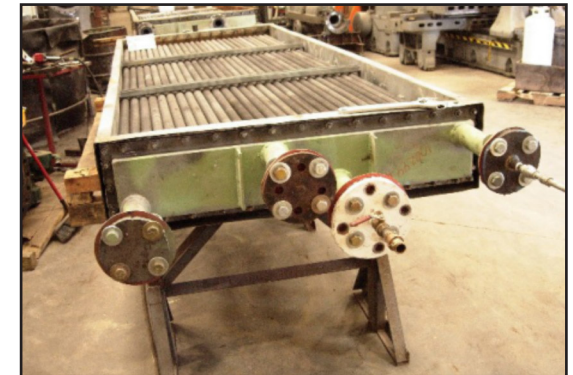
Coils being tested.

- Cooler was then hydro-tested for 3 hours at 80 psi
- Isophase cooler experienced no leaks and was put back in service
- Customer was able to meet time constraints
