## Challenge

### Issue

Scale associated corrosion causing blockage of tubes required unplanned shut downs to remove debris and clean heat exchanger. Loss of system availability impacted system performance.

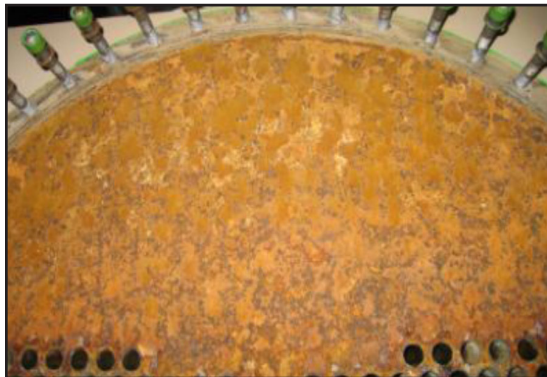
High mineral and chloride content of cooling water accelerates scaling corrosion of unprotected metal.

*Shows extensive corrosion of the metal on the tube sheet and the end cover*

- Decontaminate surfaces to remove chlorides
- Grit blast to Sa 2.5 with 3 mil (75 µm) anchor profile

1. Removable plugs inserted to prevent coating from entering tubes
2. Two coats of **ARC 855** at total DFT of 40-60 mils (1-1.5 mm) to the tube faces and end cover plate

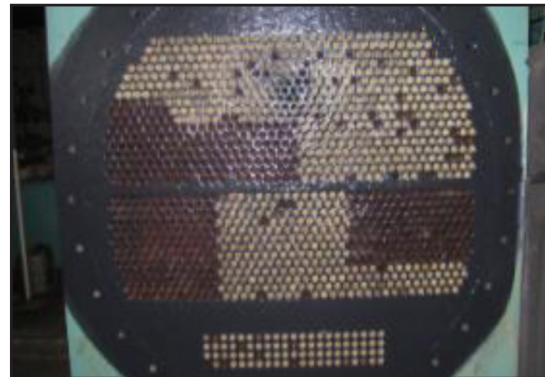
*Tube sheet in process of being coated with ARC 855*

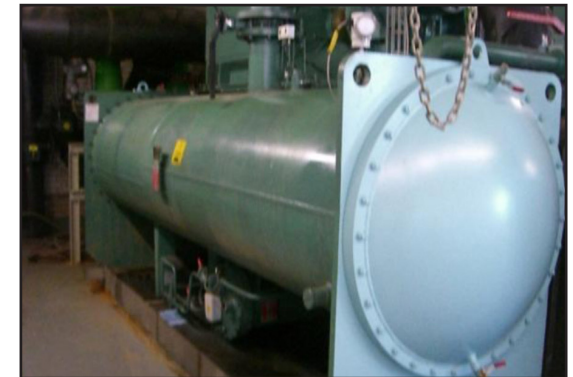
- Client reported heat exchangers were still in “perfect condition” after 24 months of service with no performance drop
- A total of 16 heat exchangers were restored with **ARC 855** coating

*A regular maintenance check at 24 months showed no sign of corrosion or scale*
