Challenge

Galvanic corrosion of supports risked loss of the traveling screens, which are critical to the safe operation of the cooling water intake system.

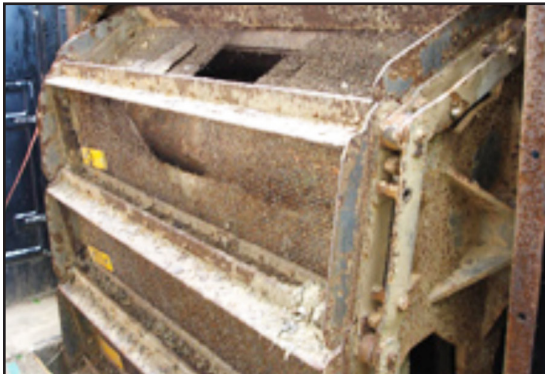
Prior coatings had inadequate dielectric properties to impede galvanic cells.

Corroded traveling screen

- Pressure wash and decontaminate the substrate
- Abrasive blast to Sa 2.5 with 3 mil (75 µm) angular profile

1. Apply 2 coats of **ARC 855** in alternating colors achieving total DFT 30-40 mils (750-1000 µm)

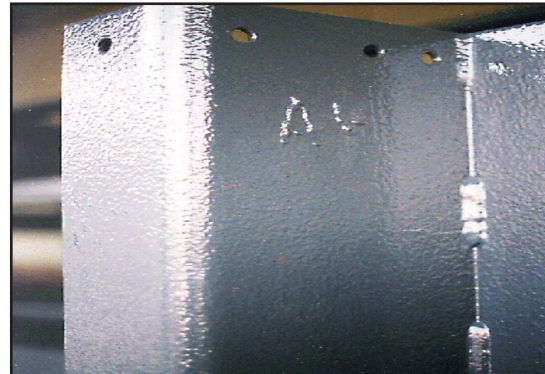
Screen supports coated with ARC 855

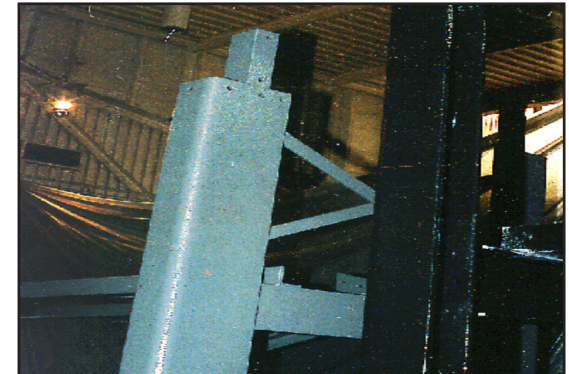
ARC 855 coating continues in “perfect condition”

Completed ARC 855 application
