Challenge

Issue

Ceramic tile lasts 4 – 6 months in this application before cracking and delamination occurs. Exposed steel wears through and requires weld repair before retiling. Previous patch material lasts <7 days.

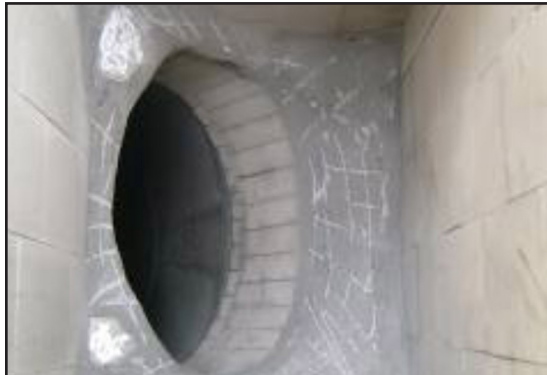
Brittle fracture failure of ceramic tiles results from impact of coal up to 10 cm (4 inch) diameter. Acidic wash water corrodes steel.

Damage to existing ceramic tiles caused unscheduled shutdown and loss of production

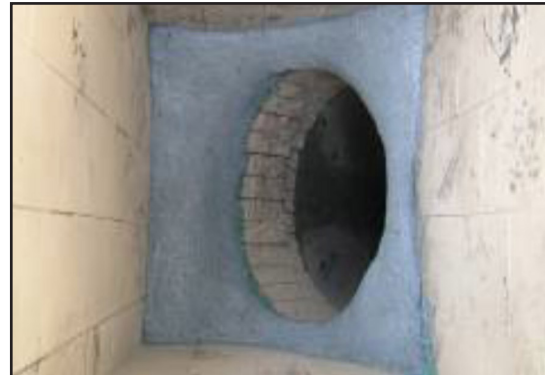
Installation of ARC BX5

1. Apply **ARC BX5** at 120 – 200 mils (3 – 5 mm) to steel and cove up onto the ceramic tile
2. Apply **ARC S2** at 12 mils (300 µm)

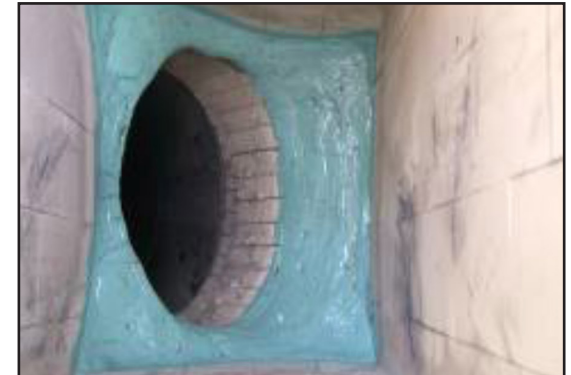
ARC BX5 with ARC S2 topcoat cures rapidly, allowing fast return to service of chute

- ARC repairs completed in 8 hours
- ARC solution provided over 6 months service before a touch-up was required
- Due to success client has selected ARC coatings as “patch repair” for all tile-lined chutes and lines
