Challenge

Corroded piping in cooling system required cleaning and repainting every 6 months, resulting in increased maintenance cost.

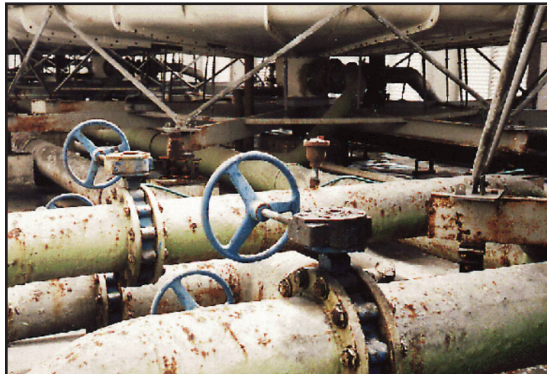
Previous coating selected not resistant to corrosion and failed semi-annually, resulting in pitting corrosion.

Original piping after 6 months

- UHPW blast surfaces to remove old coating
- Grit blast to Sa 2.5 with 4 mil (100 µm) angular profile

1. Apply **ARC 858** to weld seams and pits
2. Apply 2 coats of **ARC S2** with total ~DFT: 30 mils (750 µm)

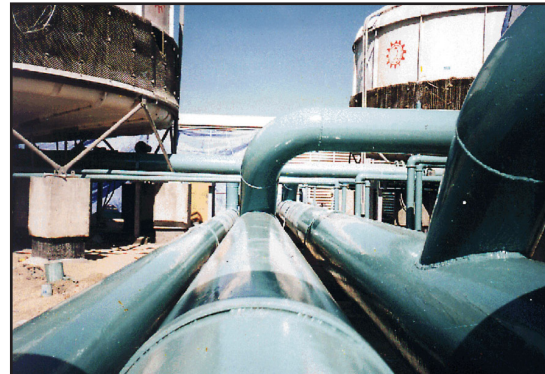
Cooling water pipes coated with ARC S2

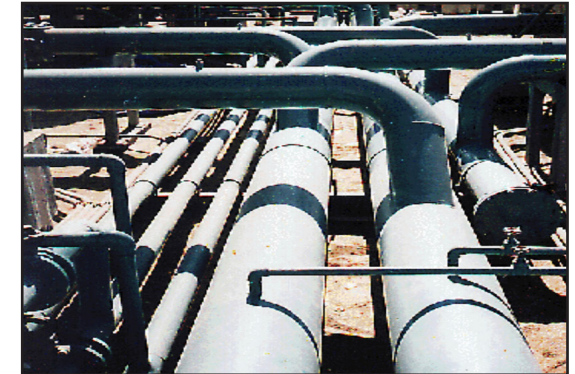
ARC coating performing after 10 years (20X previous coating life)

Completed piping system after 10 years
