## Challenge

### Issue

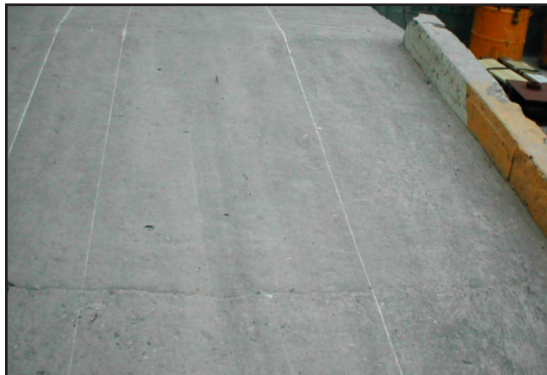
High dew point caused condensation in morning shift. Safety tape would not adhere properly and peeled away. Scoring concrete was rejected for inadequate uniformity of slip resistance.

Damaged ramp

- Pressure wash and degrease concrete to remove old adhesive residues and tire scuffs
- Diamond grinding for CSP3 profile

1. Mark surfaces and mask to create alternating strips on ramp
2. Apply **ARC 855** by roller @ 30-40 mils (0.75-1 mm) followed immediately with broadcast of #16 grit  $Al_2O_3$  and back-roll
3. Sweep excess grit off

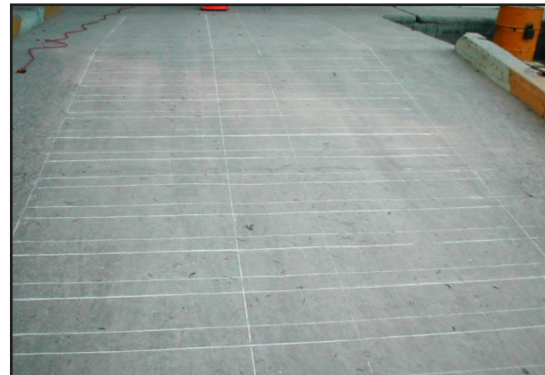
Outlined areas for roughening and coating

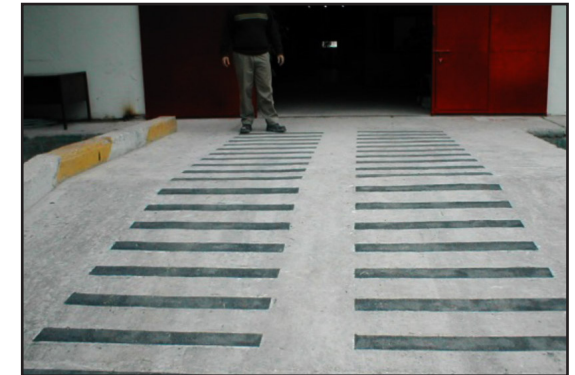
Since broadcast system has been installed, no further slipping accidents have occurred and surface remains in service after 10+ years.

Finished ramp surface
