## Challenge

Boarder buckets on continuous excavator were wearing out in less than 6 months resulting in lost production and increased maintenance costs. Traditional weld repair resulted in stress fatigue failure.

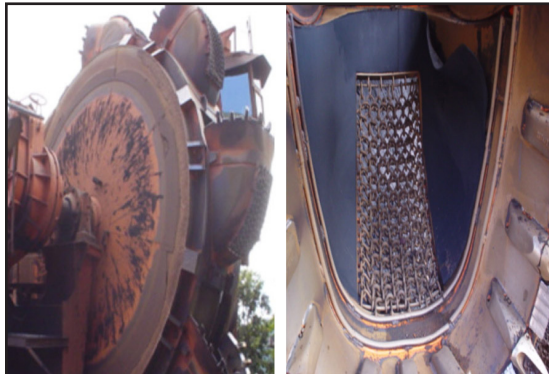
Heat-related stress fatigue was weakening grain boundaries, leading to cracks and accelerated abrasive wear.

Repair life of 6 months with hard face welding

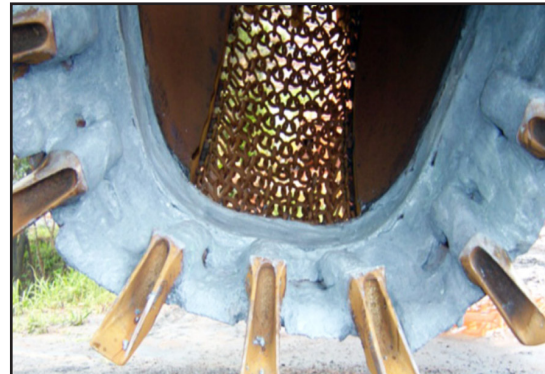
ARC coating applied to the boarders between the teeth

- Grit blast to Sa 2.5 with 3 mil (75 µm) angular profile

- Apply **ARC BX1\*** at an average thickness of 6-8 mm (250-320 mils) only to the regions exposed to sliding abrasion.

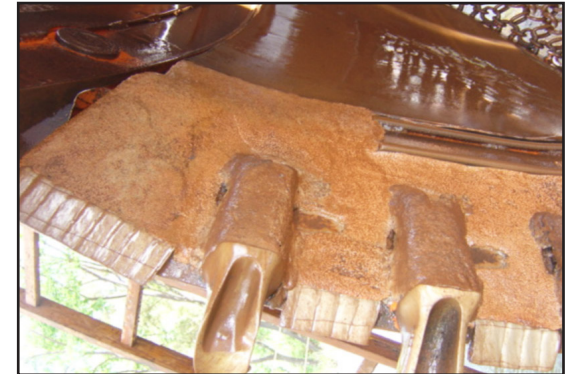
- Heat related stress fatigue minimized by using ARC
- Service life increased from 6 to >12 months
- At 20-month maintenance period 5 kg of ARC was used to repair localized damage
- ARC coating has been applied to three more excavators in same manner at this mine site

After 20 months only 5 kg of ARC was needed for repair
