Challenge

Slurry loss, due to abrasive wear on OD of header pipes, caused loss of efficiency in desulfurization absorber. Pipe replacement carried high maintenance cost.

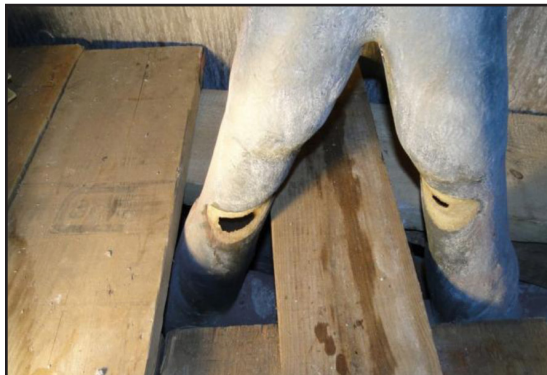
Limestone slurry abrades OD of glass reinforced plastic pipe in atomization zone.

Worn section of spray header pipes

Fabricated two-part molds to clamp on OD of pipe with set gap clearance. Abrade pipe by grit blasting.

1. Apply mold release to ID of mold
2. Apply ARC 855 as primer to pipe OD
3. Apply ARC BX2* to OD of pipe and ID of molds
4. Mold was clamped into place
5. Excess product extruded and removed

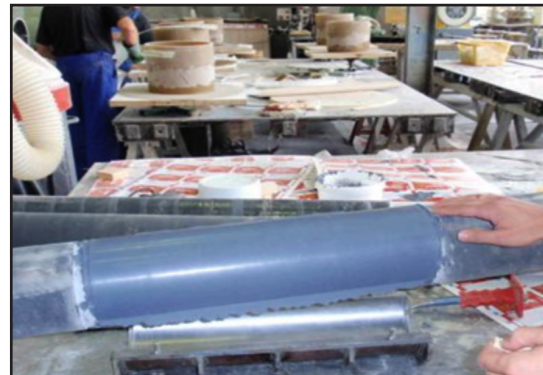
ARC coatings being applied

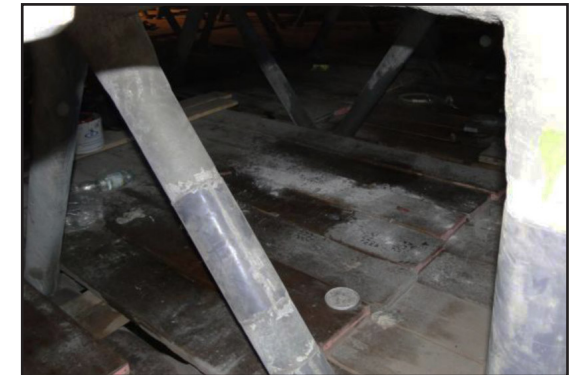
- Previously unlined pipes wore out in less than 1 year
- ARC lined pipes lasting 5+ years and only require patching to build up worn areas at a cost of <€15K

Installed service
