Challenge

Issue

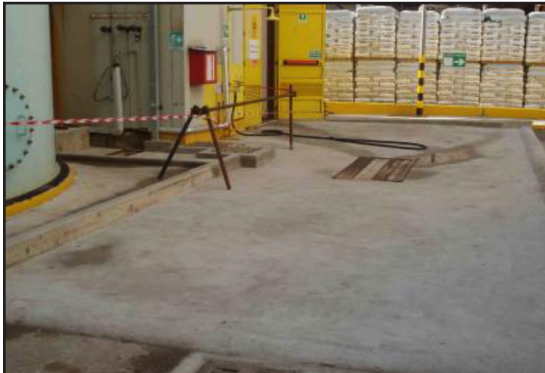
Concrete slab following surface preparation

- High pressure water blast concrete slab.
- Abrasive blast metal areas (drains, grates, etc) to Sa 2.5 with 3 mil (75 µm) profile

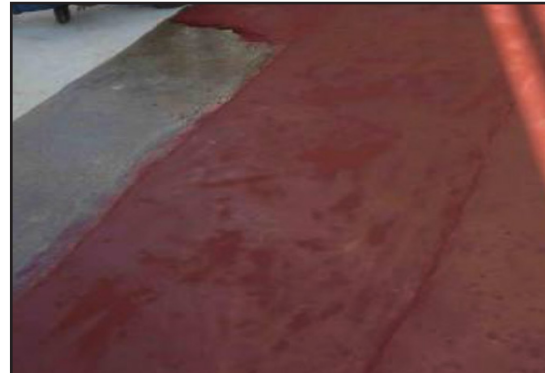
ARC 988 being trowel applied

1. Trowel apply **ARC 988** at minimum 6 mm thickness to concrete
2. Roller apply **ARC S4+** at DFT of 20-30 mils (500-760 µm) to metal grating over sumps

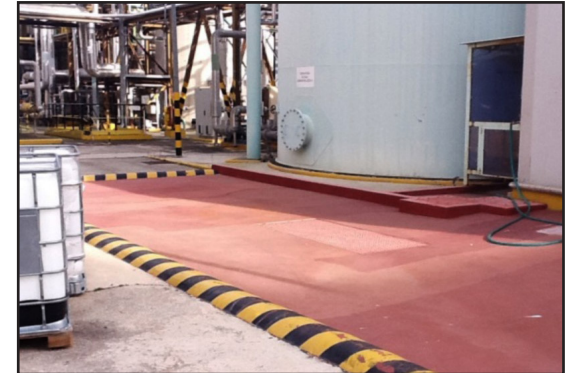
- 6 years of problem free service
- No detectable mechanical damage
- No evidence of chemical degradation
- Client quote: “The coating is performing exceptionally well.”

The area 6 years after installation
