Challenge

- To extend the life of limestone slurry, *exotic alloy* pumps, from 15 to 24 months

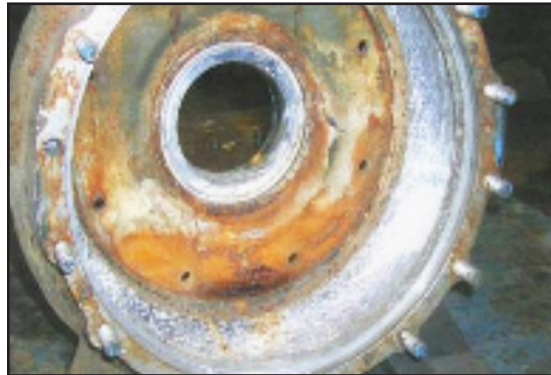
Despite 27% chrome hardened pump components (volute, back plate, suction plate) the pump became degraded by the abrasive and corrosive nature of the re-circulated slurry in 6-9 months. New parts were installed in each of 12 pumps within a 15 month cycle.

Condition of pump after 9 months

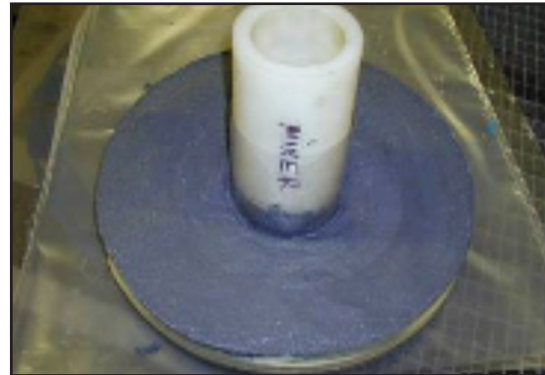
Molding the suction port

- Use UHMWPE to fabricate suction port mold
- Steam remove contaminants and soluble salts
- Grit blast to Sa 2.5 with 3 mil (75 µm) angular profile

- Apply 5 mm of BX2* to suction and backplates
- Machine suction and backplate to tolerance with diamond bit
- Rebuild cutwater and volute with 5 mm of BX2*

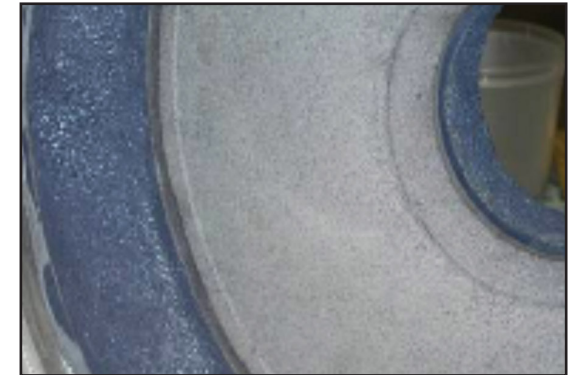
Completed application showing machined ARC surface

- Run time to date – 24 months + as of 9/08
- Client indicated prior spend at \$54K/year based on 4 pumps per absorber and 3 absorbers
- Total 12 Pumps
