## Challenge

Abrasion to internals of separator prohibited client from achieving warranty requirements. Oversize particles contaminate kiln operation. Client did not want to spend money on metallurgical upgrade.

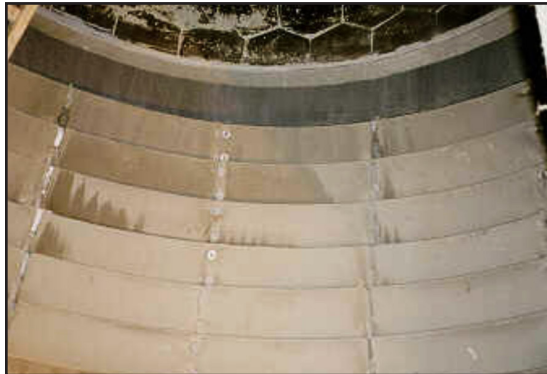
High velocity sliding wear wore vanes to such a degree that excessively large particle passed into kilns.

Typical wear regions on internals of separator

- Grit blast surfaces to 3 mil (75 μm) angular profile

1. Upper half of vanes lined with **ARC BX1\*** at .25-.375" (6,4- 9,6 mm) due to coarse particle wear
2. Lower regions coated with **ARC BX2\*** at .125-.175" (3,2-4.5 mm) for fine particle wear

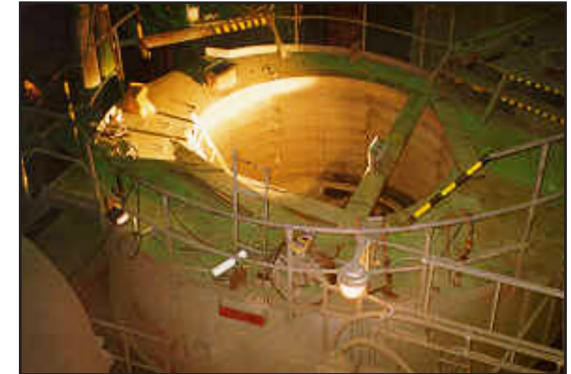
Installed rotor inside stator

- MTBF is now 3+ years, which exceeds warranty requirements
- Client has specified **ARC Efficiency and Protective Coatings** as one of their primary suppliers for wear-resistant protection of air separators
- >6 ARC-coated units have been installed in Europe, Latin America, and North America
