## Challenge

Pump volutes wore out before production campaign was completed, requiring unscheduled shutdowns and increased maintenance cost to repair.

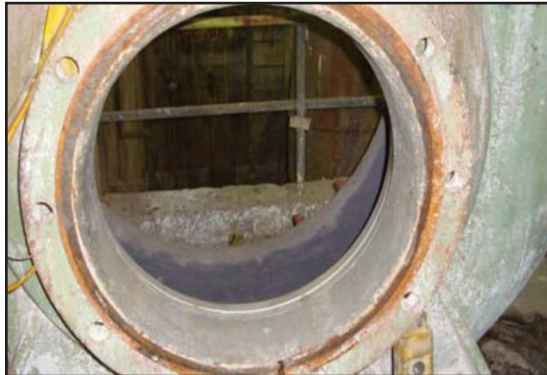
Severe abrasion and impact from unprocessed sugar beets, covered with sand and grit, wear internals prematurely.

Damaged pump casing

- Grit blast to Sa 2.5 with 3 mil (75  $\mu$ m) angular profile

1. Apply **ARC BX2\*** @ 120-160 mils (3-4 mm)
2. Apply 1 coat of **ARC 855** @ 15-20 mils (375-500  $\mu$ m) to improve hydraulic efficiency

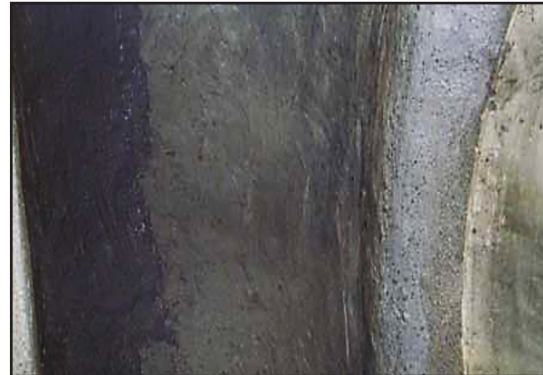
ARC BX2\* and ARC 855 applied to pump volute

\*ARC BX2 is the "Bulk" package size of ARC 897

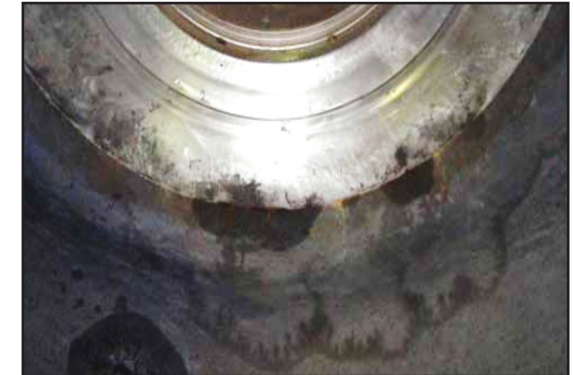
- Pump operated for complete campaign cycle without unscheduled shutdown
- Minimal wear to coated surfaces easily repaired
- Scrap and repurchase of casings reduced by 75%

Condition of coating at end of operational cycle
