Challenge

Existing packing lasted only three days due to abrasive gypsum slurry in fertilizer mineral manufacturing process. Shaft required replacement every few days.

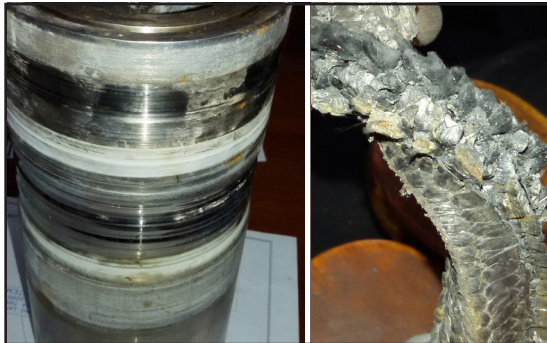
Existing packing failed due to a loss of compression, allowing the gypsum mineral to enter the stuffing box, fret the shaft, damage the packing, and cause uncontrollable leakage.

Gypsum slurry was getting under the packing set, resulting in damage to both the shaft and packing.

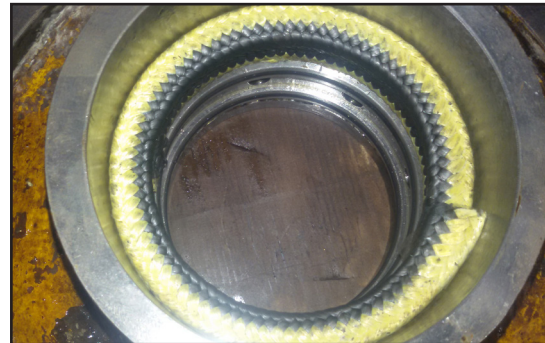
DualPac 2211 Packing installed. Note that middle rings are oriented with the aramid on the OD to create a tight seal that needs fewer adjustments.

- Installed five rings of **DualPac® 2211 Packing** as shown below.

- DualPac Packing** uses patented braiding technology that combines graphite filled ePTFE with a high strength and resiliency aramid. It results in significantly longer packing life and low wear on shafts.
