## Challenge

A chemical plant which produces raw materials for use in the body care industry was experiencing sealing issues with their shell and tube heat exchangers. The equipment was subjected to constant temperature cycling and had premature failure despite preventative maintenance.

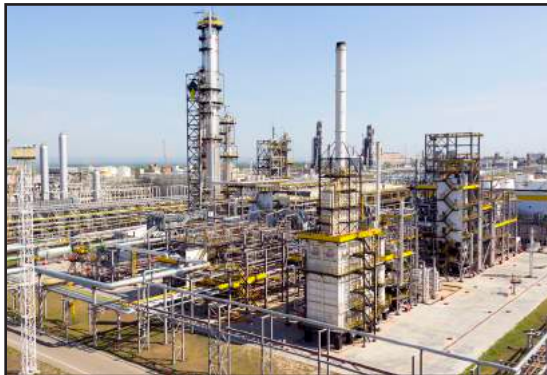
The heat exchanger operated at pressure of 20 bar (790 psi); 220°C (428°F)

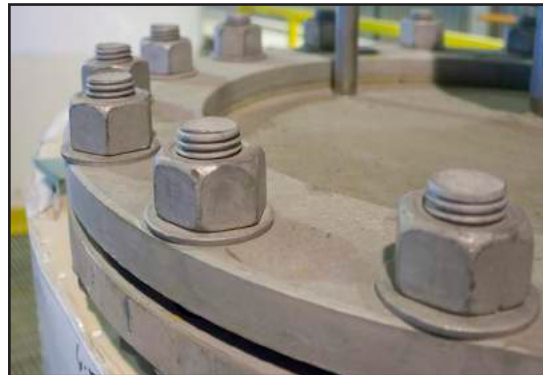
The new system provided constant pressure for the M20 bolts.

The heat exchanger was upgraded with **Chesterton's Live Loading System:**

- **Chesterton 5500 Flange Bolt Disc Springs** maintain constant compression on the gasket seal to reduce/eliminate leakage.
- **Chesterton Steel Trap™** metal/graphite gaskets withstand high pressure and high temperature as well as increased blow out safety. It can be manufactured in virtually any shape.

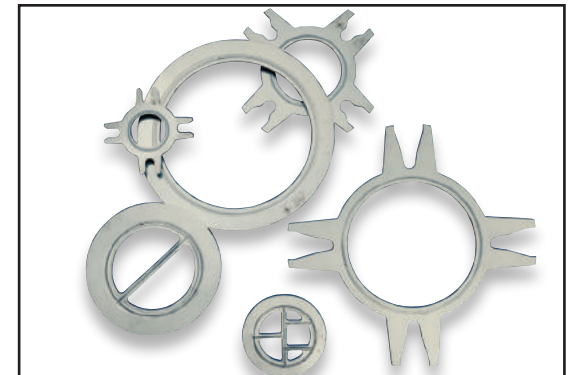
The **Steel Trap** gasket provides improved performance with minimum seating stress

Premature failure of the heat exchanger is no longer an issue with **Chesterton Live Loading** systems. The **Steel Trap** gasket is changed yearly for preventive maintenance.
