## Challenge

### Root Cause

## Solution

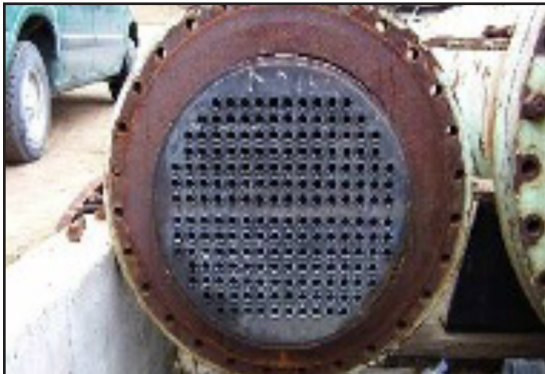
Severe bi-metallic corrosion due to dissimilar metallurgy of the tubes and the tube sheet, exacerbated by chemically corrosive cooling water.

Corroded tube sheet

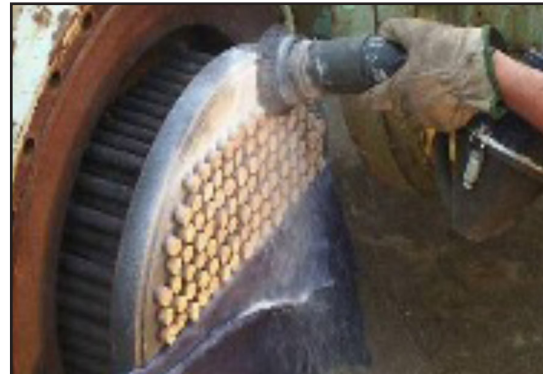
Surface preparation and tube protection

- Steam clean at 100 bar (1400 psi) with steps to test for and remove chlorides
- Insert plugs to protect tubes
- Vacuum grit blast to Sa 2.5 with 3 mil (75 µm) angular profile

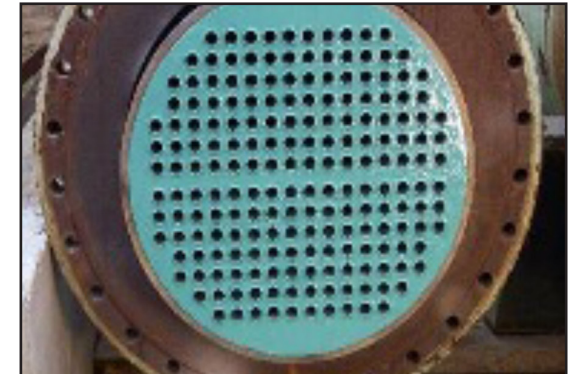
Protected tube sheet

1. Rebuild pitted areas with [ARC 858](#)
2. Apply 2 coats of [ARC S2](#) total ~DFT: 60 mils (1500 µm)
