Pitting of carbon steel tanks used for acid and caustic storage during demineralized water treatment had destroyed unprotected tanks within 3 years, requiring tank replacement.

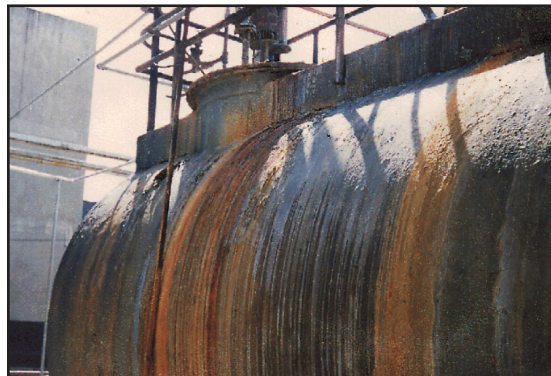
As tank level drops, 98% H₂SO₄ in head space drops to <93%. Carbon steel is no longer resistant to corrosion at this level.

Corroded tanks, containing 98% H₂SO₄

- Grit blast to Sa 2.5 with 3 mil (75 µm) angular profile

1. Stripe coat internal weld seam with 1 coat, followed by 2 coats **ARC S4+** in alternating colors with a total DFT of 30-40 mil (750-1000 µm)
2. Apply 2 coats of **ARC S2** with total DFT 20-30 mil (500-750 µm) on the tank exteriors

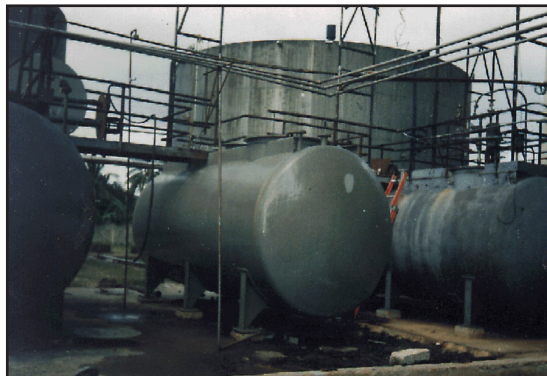
New tanks coated with ARC S4+ internally and ARC S2 externally

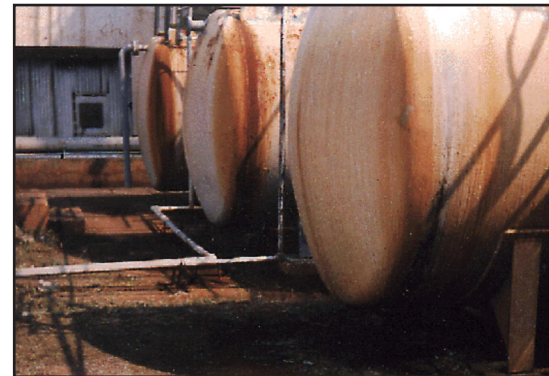
- After 36 months in service, no flaws could be found in the lined surface
- Some ultra-violet-light related chalking on externals. Aliphatic urethane coating applied to address chalking
- After 60 months tanks are still in excellent condition
- After 13 years of service, ARC coatings is preferred protection for these assets

After 13+ years, only chalking and staining is evident
