Challenge

Issue

Premature wear of basalt-cast-lined connectors in <6 months result in loss of production capacity. Repair of basalt liner requires shipping off-site with increased lead time.

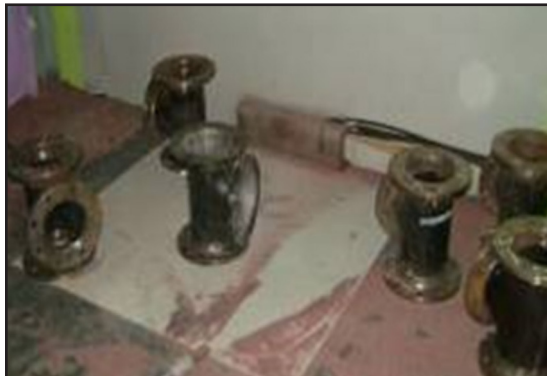
Impact and wear from fine coal particles cause brittle fractures and wear of basalt liner.

New “T” pieces awaiting coating

- Remove existing liner
- Grit blast to Sa 2.5 with 3 mil (75 µm) profile

1. Fabricate UHMWPE* mold to ID – 16 mm
2. Prime ID with **ARC MXP** @ 10 mil (250 µm)
3. Preheat part A of **ARC MX1** to 110°F (42°C) then mix with part B and part C
4. Center mold and pour **ARC MX1** into annular gap, then compact with tool
5. When cured, remove mold

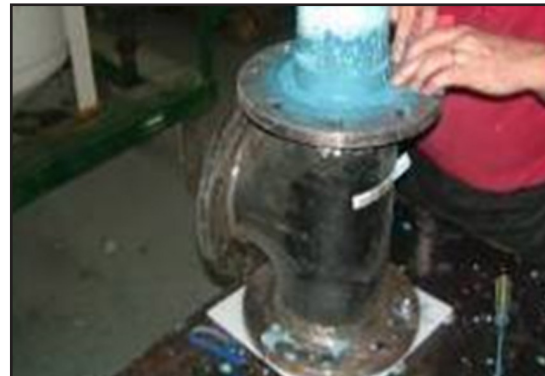
Compacting ARC MX1

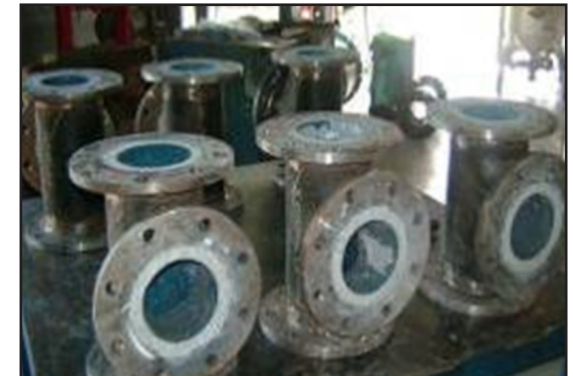
ARC coated surfaces

- Extended connector life to >18 months (3X)
- Connectors easily repaired on site
- Offsite shipping eliminated
- Turnaround time improved by 16 days
- Client requested **ARC MX1** as OEM liner for new “T” pieces
