Challenge

Combustion of fossil fuels in cement production led to corrosive off-gases damaging the frames holding the filter bags within 1 year after installation. If the bag drop unit does not function properly, the client is subject to environmental fines.

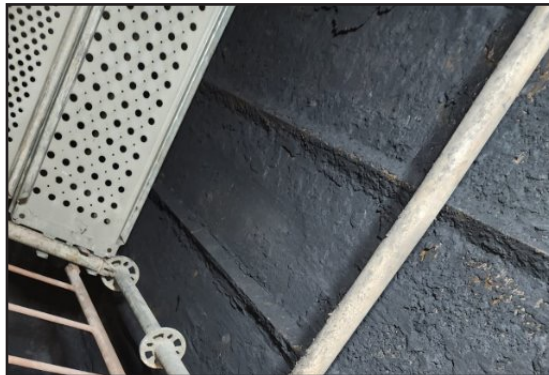
Combustion gases contain SO_2 which cools in the upper section of the baghouse and condenses to form H_2SO_4 .

Corrosion inside bag house.

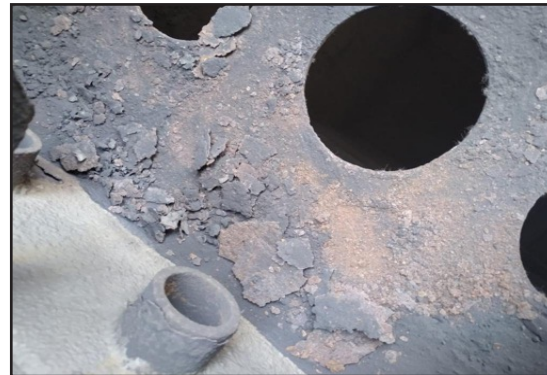
Severe corrosion at bag frame plate.

All identified wear zones were HOP water washed and neutralized, then grit blasted to Sa 2.5 with a 75 – 125 μm (3 – 5 mil) angular profile.

Chesterton® ARC 858 Abrasion Resistant Rebuilding and Faring Composite was used to fare pitted regions and address thin surfaces. Following faring with ARC 858 two coats of Chesterton® ARC SD4i Ceramic-Reinforced Coating were applied at 375 – 500 μm (15 – 20 mils).

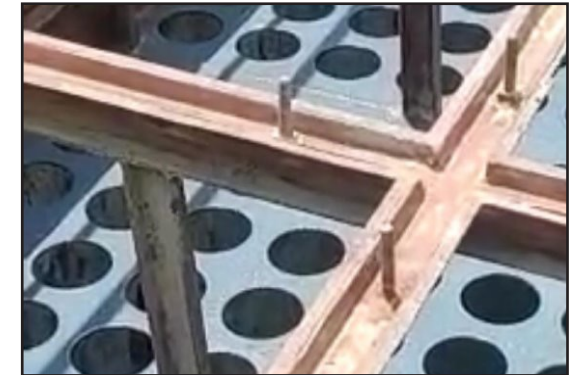
Emergency shutdowns have been significantly decreased and the effects of corrosion have been mitigated. The baghouse dust collector has been in service for 2 years with little corrosion.

Equipment with ARC SD4i applied.
