Challenge

The tiled floor adjacent to a paper machine experienced extensive cracking and delamination, creating a tripping hazard and housekeeping concerns.

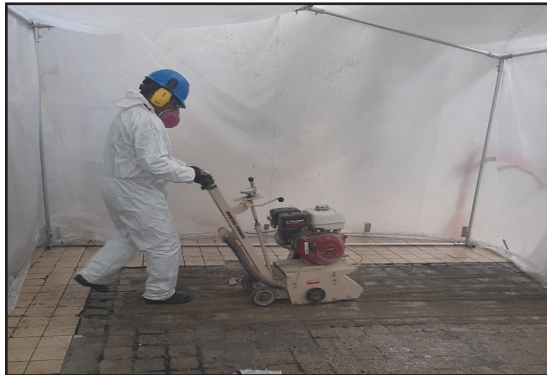
Contaminated wash water wicks in through grout lines leading to spalling of the tile.

Old tile removed and concrete scarification.

All tiles were removed and the surface was ground to an ICRI CSP 3-4 finish.

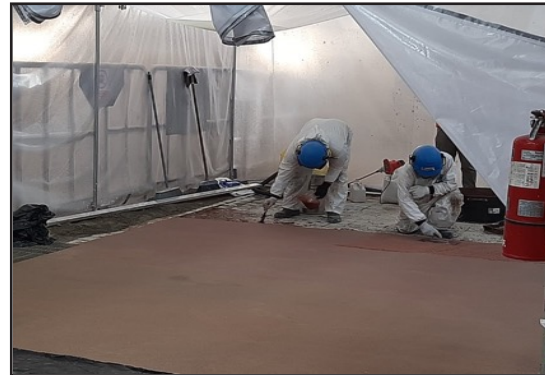
Resurfacing with ARC EG-1.

Chesterton® ARC EG-1 was applied as a grout at 6 – 9mm to level the floor after the tile removal. A final coat of Chesterton ARC CS2 was then applied at 375 – 500 µm (15 – 20 mils). While still wet, a broadcast aggregate was applied to provide slip resistance and a final 250 – 375 µm sealer coat was applied.

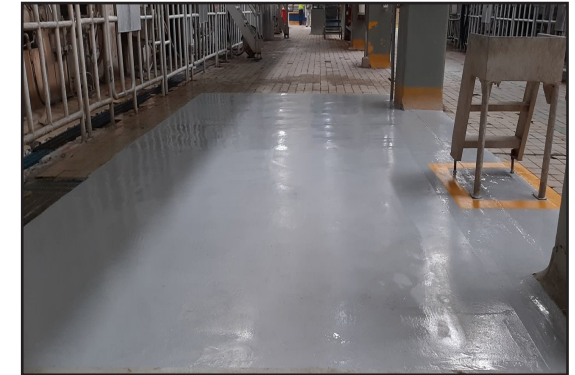
The treated floor area is almost completely intact after 2 years in service. Very little lifting or delamination has occurred. The surface is sealed with no visible attack to the underlying concrete. The plant is expanding use of ARC EG-1 and CS2 with an additional 600M² to be coated in 2024.

ARC S2 with broadcast and sealer coat.
