Challenge

Servo motor cylinders at a hydropower plant were leaking—leading to inconsistent performance, unplanned maintenance, and environmental concerns.

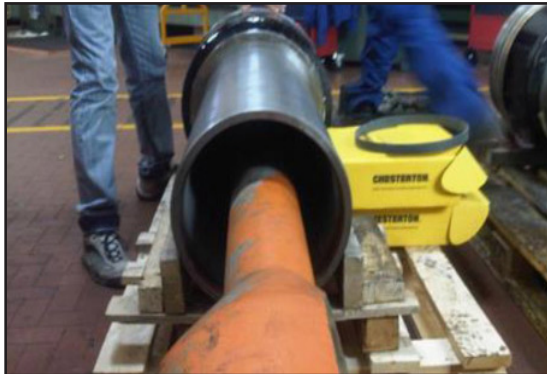
OEM rubber U-cup seals had to be replaced regularly a maximum of every two years on all servo motor cylinders (controlling the wicket gates) which resulted in lost production.

Servo motor cylinders being rebuilt.

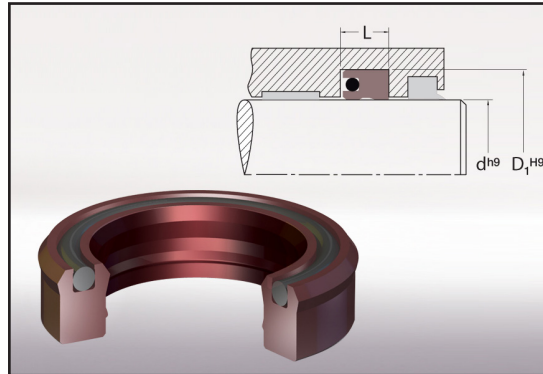
Chesterton R22KE - Unique lip geometry stabilizes seal to prevent rolling, o-ring increases pre-load and negative rake profile eases installation.

- Chesterton 22KE single continuous U-cup incorporates an energizer for increased pre-load while providing added stability during operation

- AWC 800, a proprietary thermoset polymer, which provides excellent abrasion and hydrolysis resistance

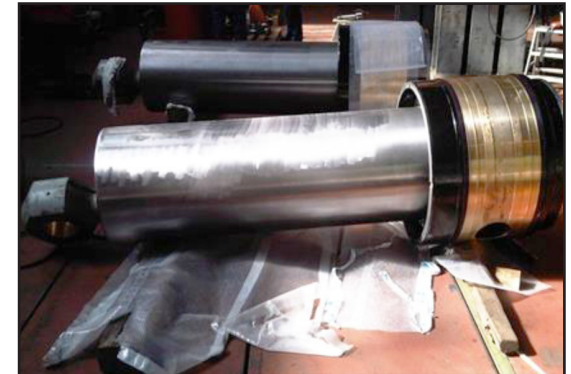
Servo motor rebuilt with Chesterton 22KE seal design made from AWC 800 polymer.

- The Chesterton sealing solution extended the rebuild cycle from 2 years to 5 years
- This success enabled the customer to maintain Servo motor cylinder operations 24/7/365
- Eliminated environmental and safety concerns on this equipment while improving equipment efficiencies
