## Challenge

Reduce plant's frequent bearing failures which were constantly stopping production. Electric motor reliability is critical in continuous automobile production.

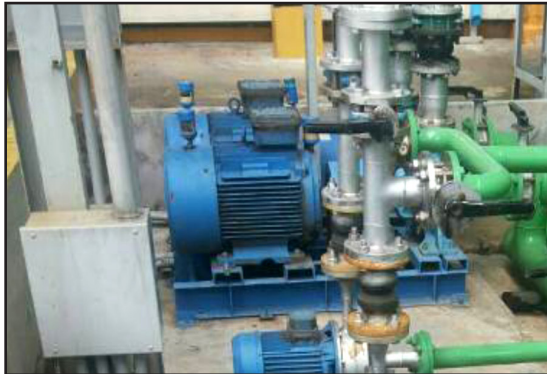
Frequent greasing to purge bearing contamination of equipment in this wash and pre-paint preparation plant was ineffective. The practice led to over-greasing of bearings. In addition, some areas were in hard-to-reach locations.

*Inconsistent re-lubrication was contributing to motor bearing failure.*

- Install a **Lubri-Cup™ VG Mini Automatic Greaser Dispenser** to apply **Chesterton 630 SXCF**, a synthetic, high-load, corrosion-resistant grease on each electric motor bearing
- Based on bearing size and speed, the **Lubri-Cup** was set for 6 months. It applies the correct amount of grease at the necessary intervals
- 300 electric motors were converted to this Chesterton solution throughout the plant

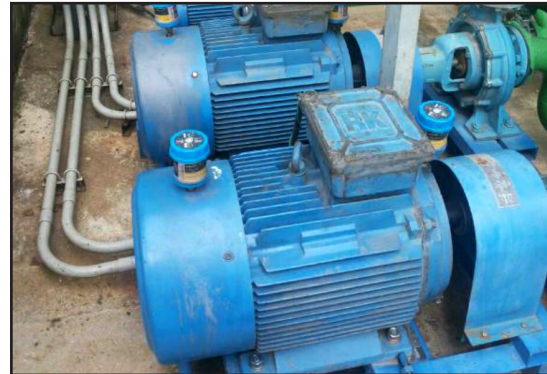
*Chesterton's electric motor reliability solution was installed.*

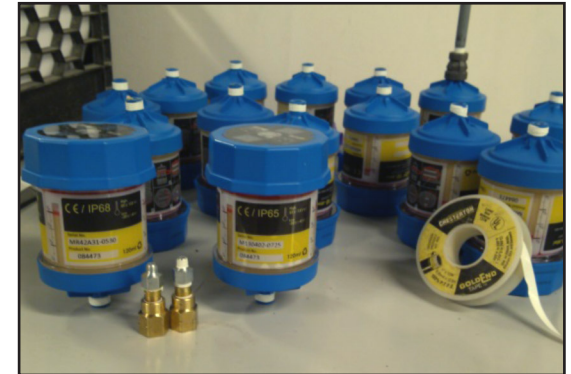
*Solution reduced electric motor failure in this area of the plant by 75%.*

- Resulted in a 75% reduction in electric motor failures on the pre-paint production line
- Dramatically increased productivity
- Reduced significant repair costs
- Reduced labor costs by eliminating manual lubrication
