Challenge

Premature wear of tile and rubber lined discharge chutes at 1,500 hours reduced development of heap leach piles, impairing enriched leachate production rate.

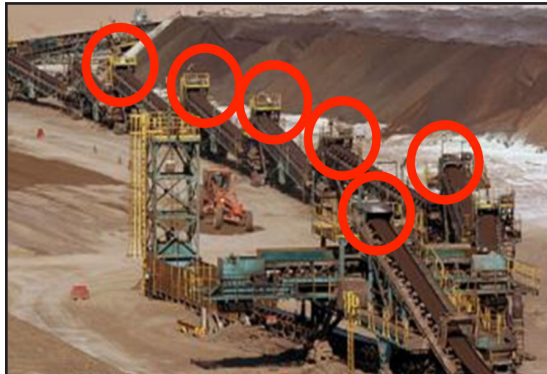
Highly abrasive copper ore, treated with H₂SO₄, wears away lined chutes and perforates steel substrate.

Circles indicate location of deflector chutes

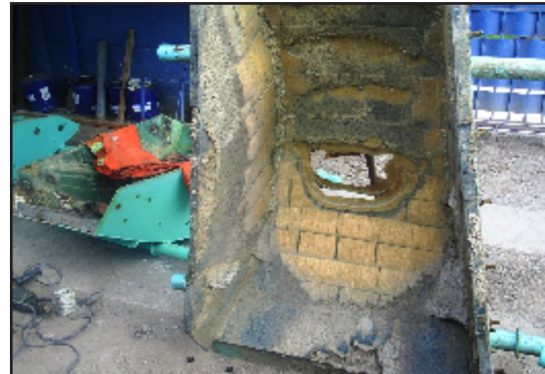
Rubber and tile lined chute after 1,500 hours

- Clean surface with high pressure water
- Mechanically roughen exposed surfaces

1. Apply **ARC BX1*** @ 1" (2.5 cm) thickness to remaining tile and rubber surfaces
2. Apply 2 coats of **ARC S2** @ total DFT 20 mils for reduced hang-up

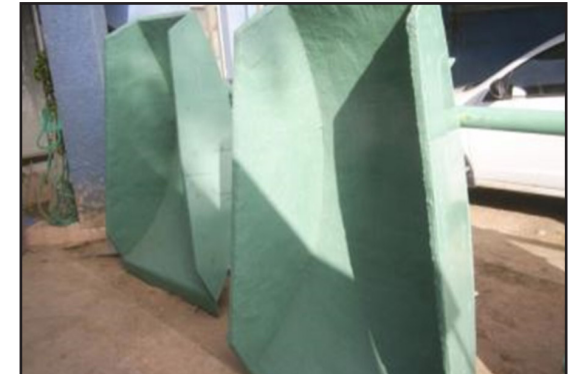
- Chute life extended to > 4,500 hours (3X)

ARC BX1* coated chutes with ARC S2 topcoat
