Bearing Life at Marine Port Increases 10X with Chesterton® 615 High Temperature Grease

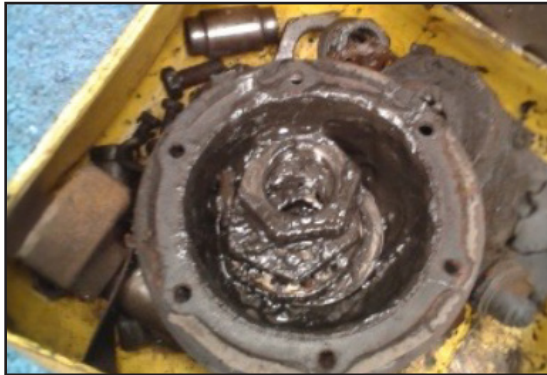
Marine port equipment including hoists, winches, motors, yard lifts, cranes, and lifting booms were frequently out of service due to bearing failure. Expensive fines were incurred due to lengthened turnaround times on cargo discharge or loading.

Marine port equipment stopped due to failed bearings and insufficient greasing.

All critical bearings on cranes, hoists, and lift trucks were cleaned with **Chesterton® 274 Industrial Degreaser** to remove old grease, sludge, and varnish buildup. Following cleaning and inspection, salvaged bearings were lubricated with **Chesterton 615 HTG #2 Grease**.

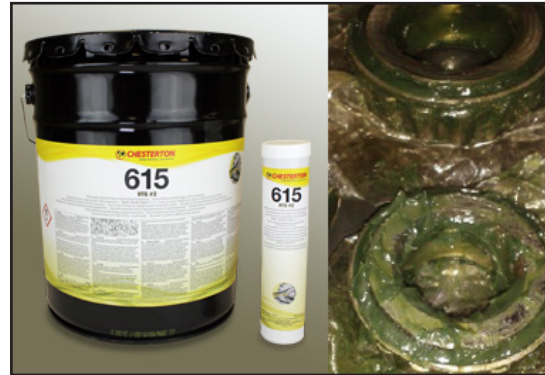
615 HTG #2 Grease lubricates bearings and helps prevent rust in marine conditions.

Likewise, new bearings were cleaned of storage compound and greased with **Chesterton 615 HTG #2 Grease**.

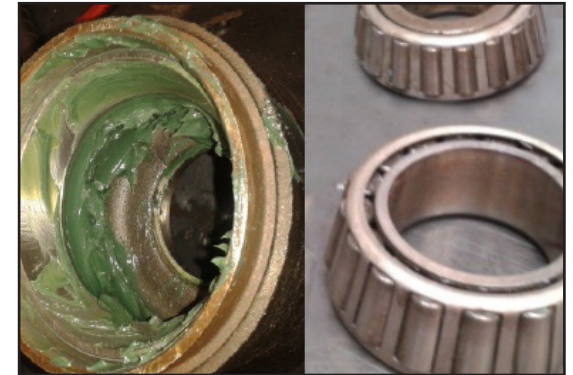
Bearing housing and bearings show fewer signs of corrosion and wear after use of 615 HTG #2 Grease.

Bearing life on yard lifts, cranes, hoists, and winches was increased by 10X.
